AP1000 Normal Operation

AP1000 Design Basis Accident Begins

AP1000
Chimney Effect
Draws
Radioactivity
Directly Into The
Environment

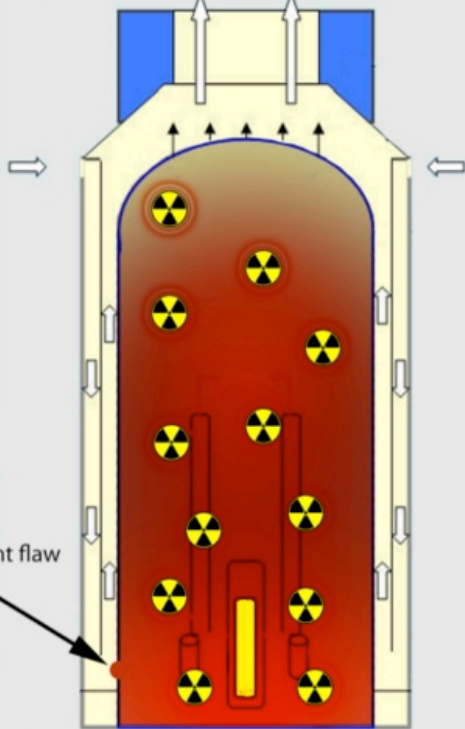
Containment Fills With Radioactive Gases
AP1000 Design Basis Accident Begins

Preexisting
containment flaw
